Rectangular abovement basin with overflow

This rectangular basin with overflow has simple lines and a low above-counter profile with good capacity.

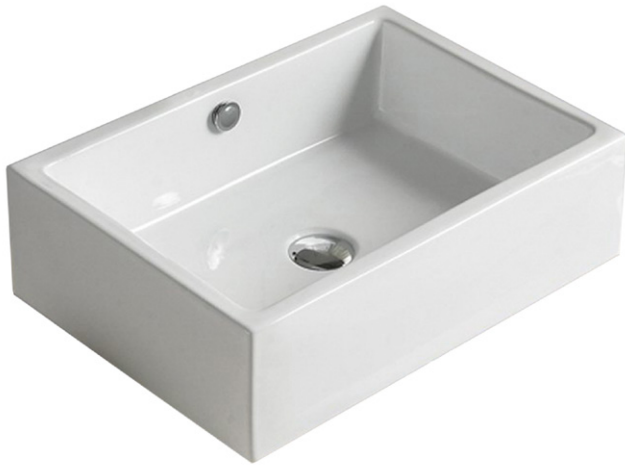
ORDER CODE	191862	Vero ceramic basin	Old code: SBC-P23
TAPHOLE	No taphole.		
WASTE	Suits 32 mm waste.		
OVERFLOW	Basin has overflow.		
MATERIAL	White vitreous china.		
FIXING	Always use the actual basin to verify cutout. Use silicone sealant. Do not use epoxy type adhesives.

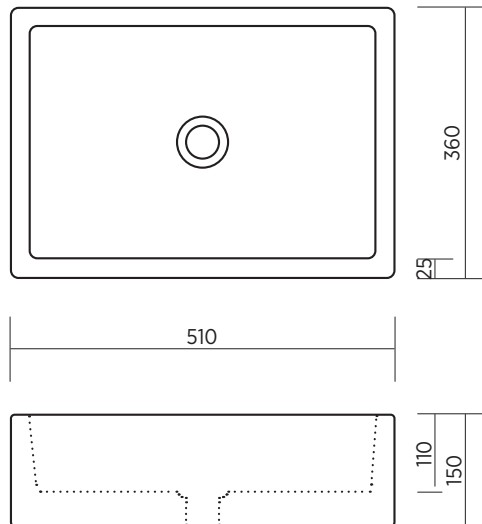
Basin has integrated overflow

- All measurements are in millimetres.
- Dimensions are nominal and subject to normal ceramic manufacturing variations of ±5mm.
- Fixing: Use silicone sealant. DO NOT USE EPOXY TYPE ADHESIVES.
- Always use the actual basin to verify cutout.
- Specifications may vary without notice as part of our continuous improvement practices.
- Clean with a damp cloth. Do not use abrasive cleaners, liquids or pastes.
